Investigations Aimed to Improve Tailgate Serviceability at Dartbrook Mine

INVESTIGATIONS AIMED TO IMPROVE TAILGATE SERVICEABILITY AT DARTBROOK MINE

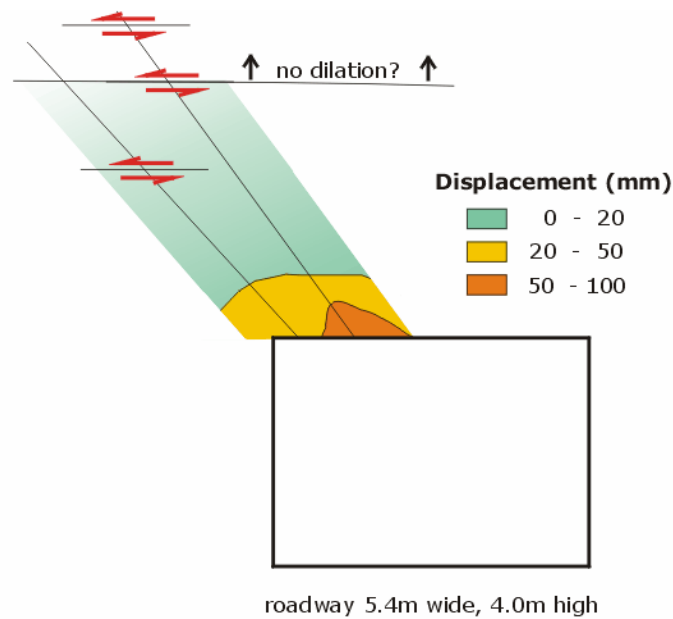
Results from the 5 Cut-through monitoring site are summarised in Figure 2. The location of and sense of shear displacement is apparent. A contour of displacement measured by the extensometers is also shown.

Figure 2 Displacement summary - Longwall 6 tailgate, inbye 5 C/T.
